U.S.D.A. FOREST SERVICE
RESEARCH PAPER
FPL 171
1972

**EVALUATION OF
ADHESIVE-BOND QUALITY
IN TELEPHONE CROSSARMS
AFTER 16 TO 23 YEARS
OF EXTERIOR EXPOSURE**

R. W. JCKERST, Technologist
Forest Products Laboratory,¹ Forest Service
U.S. Department of Agriculture

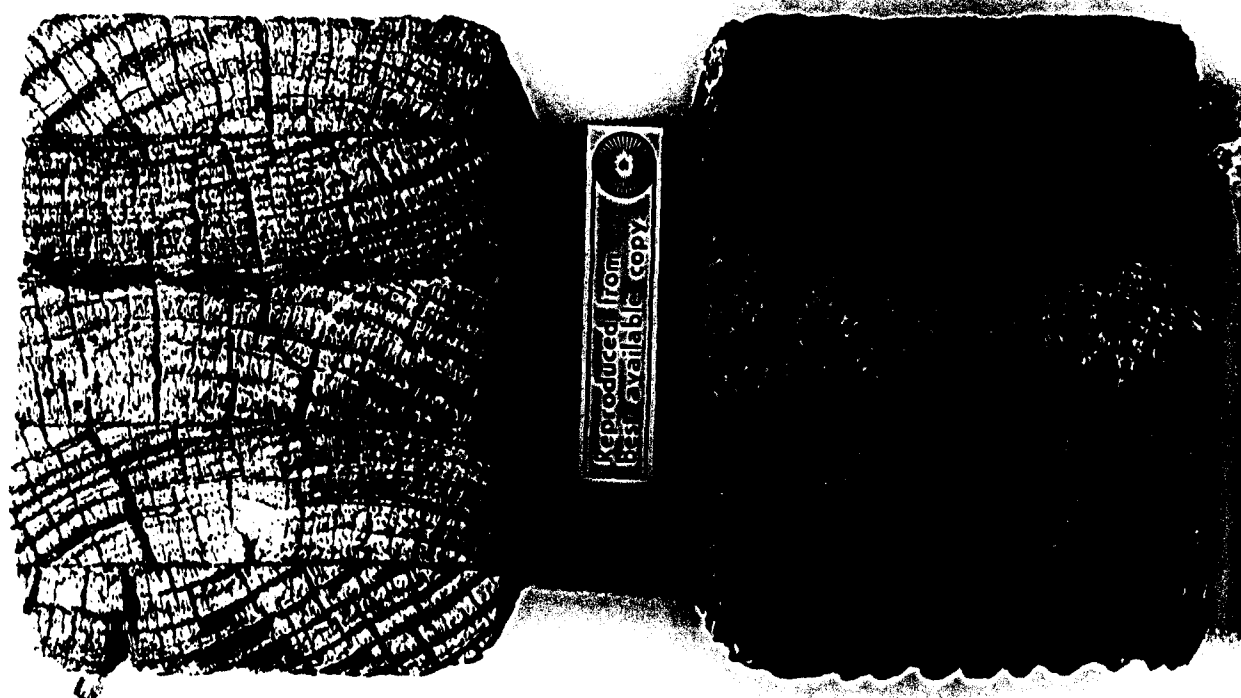
M 138 590

Figure 2.--End view of two crossarms; the arm on the left was treated with a preservative in light oil; the one on the right with a preservative in heavy oil. The heavy oil apparently acted as a water repellent and significantly reduced checking.

Group VI consisted of nine laminated southern pine 10-foot crossarms. Six of the arms in this group were five-ply, and three were of three-ply construction. The latter three were made with the outer plies of 8/4 thick, and the inner ply of 4/4 material (see figure 2). The arms in this group were manufactured in 1951 using a phenol-resorcinol adhesive and preservative treated with creosote. These arms were placed on exposure at Chester, N.J., in late 1951.

The general appearance of most of the cross-arms was good. The arms treated with a preservative in a heavy oil exhibited less checking than did the arms treated with a preservative in a light oil carrier (fig. 2). Group III, which had been treated with penta, showed decay present at finger joints and in insulator-pin holes.
